# IWRB Managed Recharge Program

## Henry's Fork Watershed Council

**Wesley Hipke**

December 4, 2018

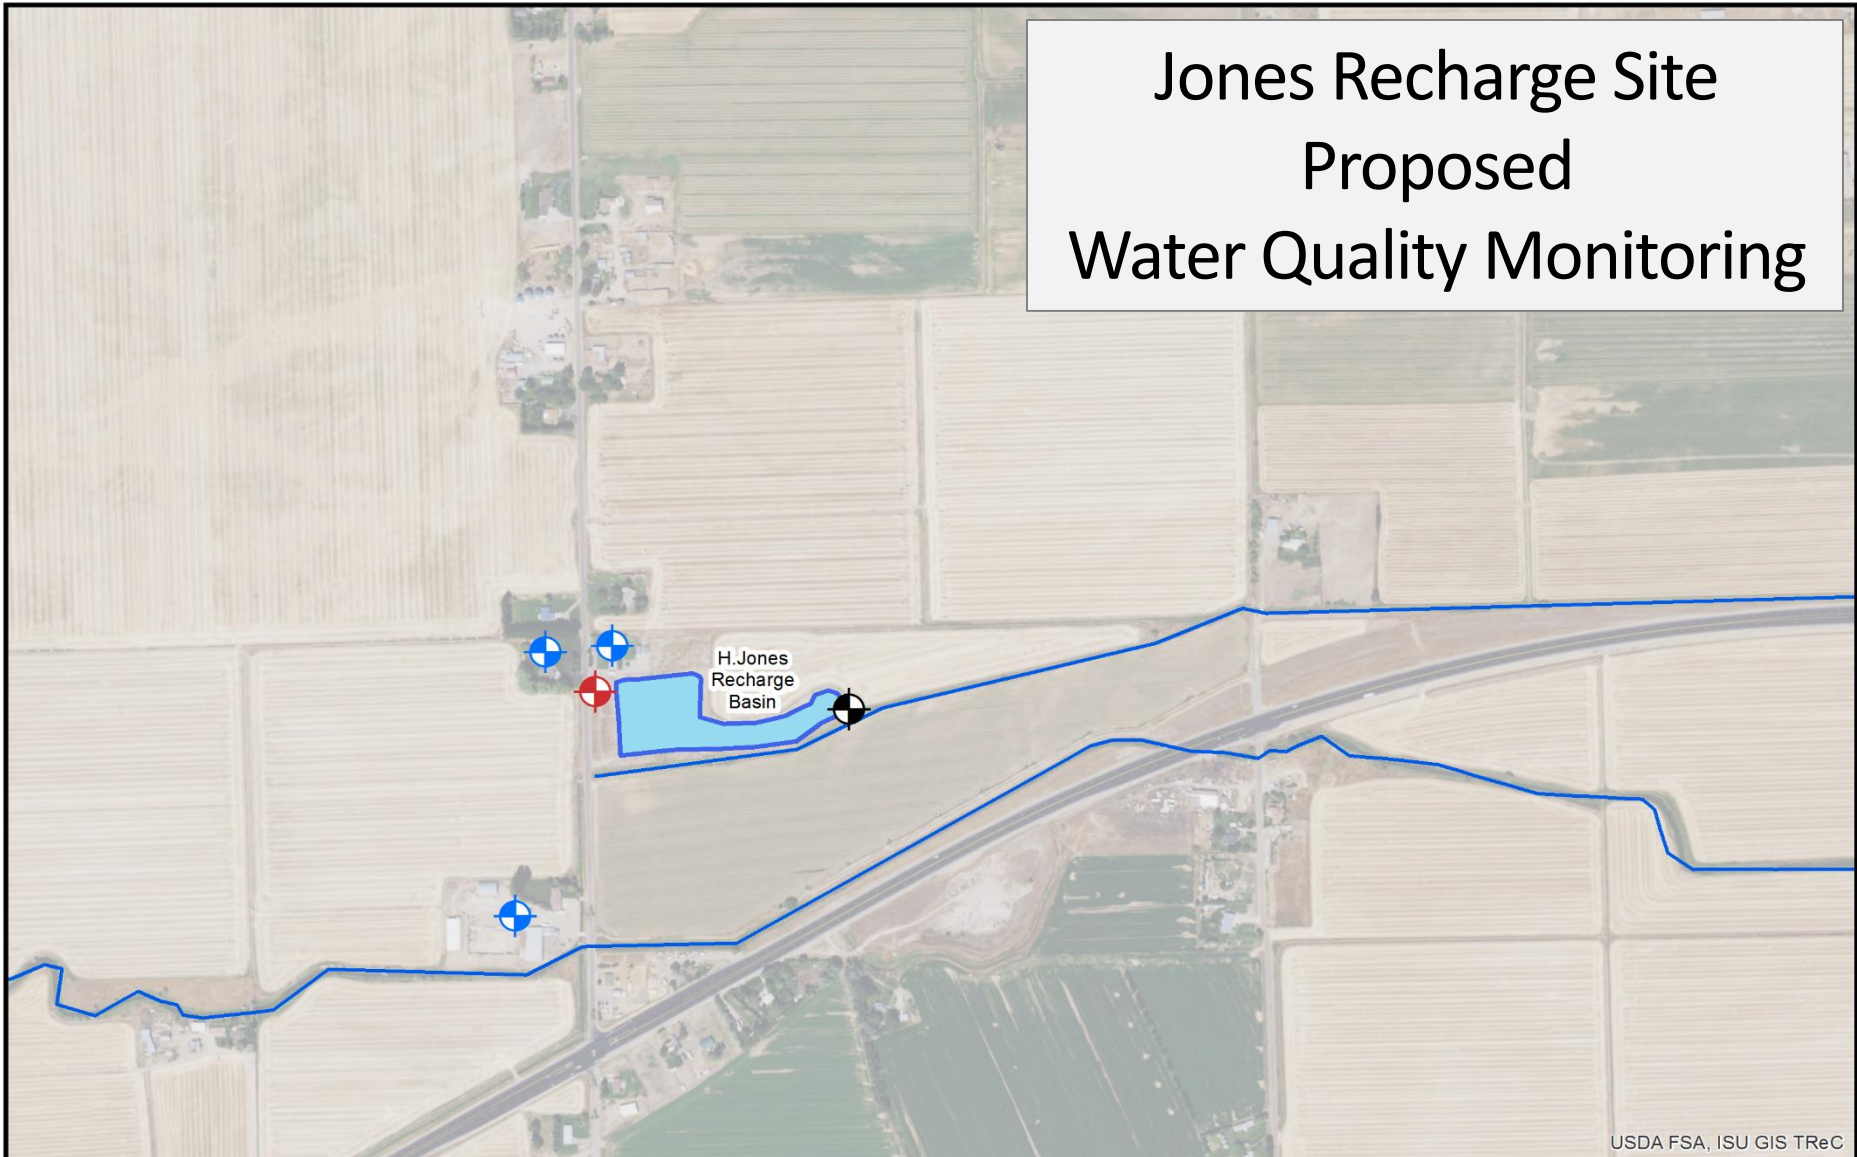
Figure 6.

# Jones Recharge Site Proposed Water Quality Monitoring

Proposed Monitoring Locations  
Harold Jones Managed Recharge Basin
