# WIRE Project Update: Ashton Wastewater Treatment Plant assessment

Henry's Fork Watershed Council  
October 13, 2015

Rob Van Kirk, Christina Morrisett, Abi Cano  
Henry's Fork Foundation

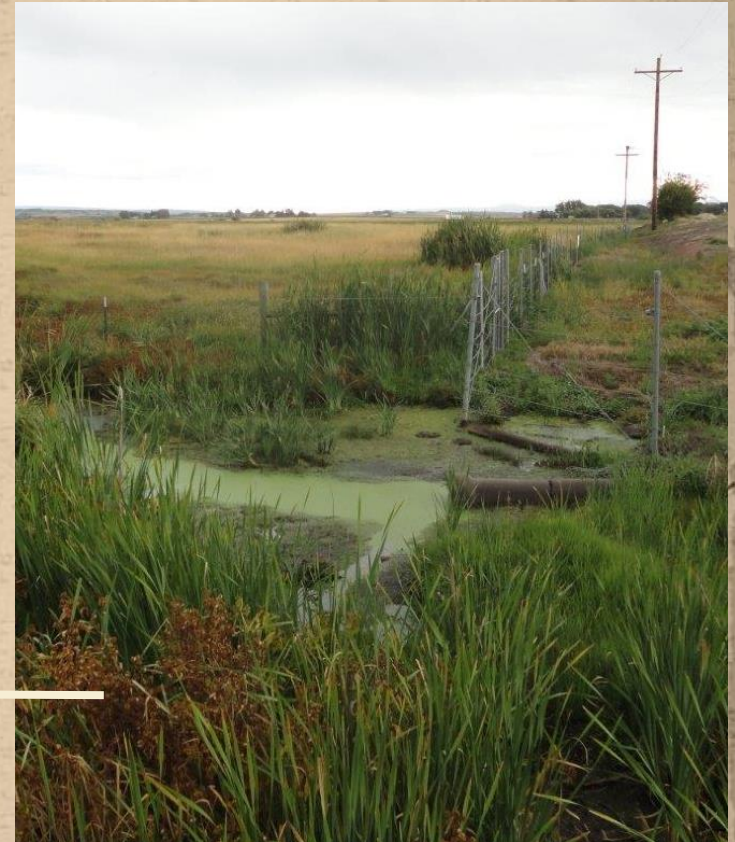
EPA photo, Sept. 2013  
Plant not discharging

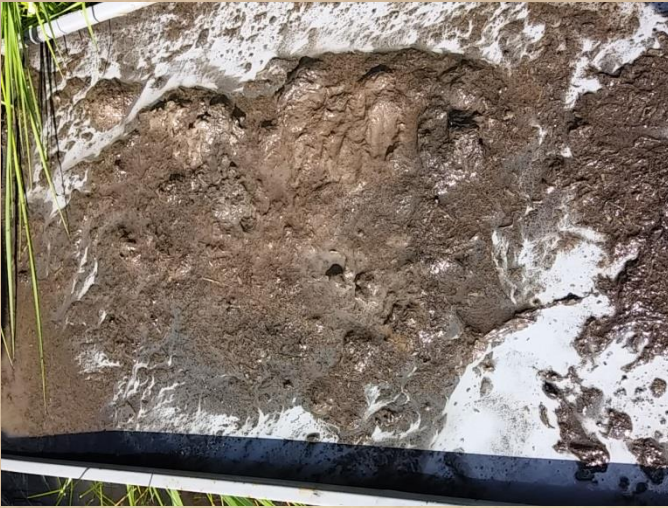
Upstream of culvert

All gravel is from roads and lagoon dikes.
